Bridges

INCREMENTAL I-GIRDER LAUNCHING METHOD FLIES HIGH ON IOWA JOB

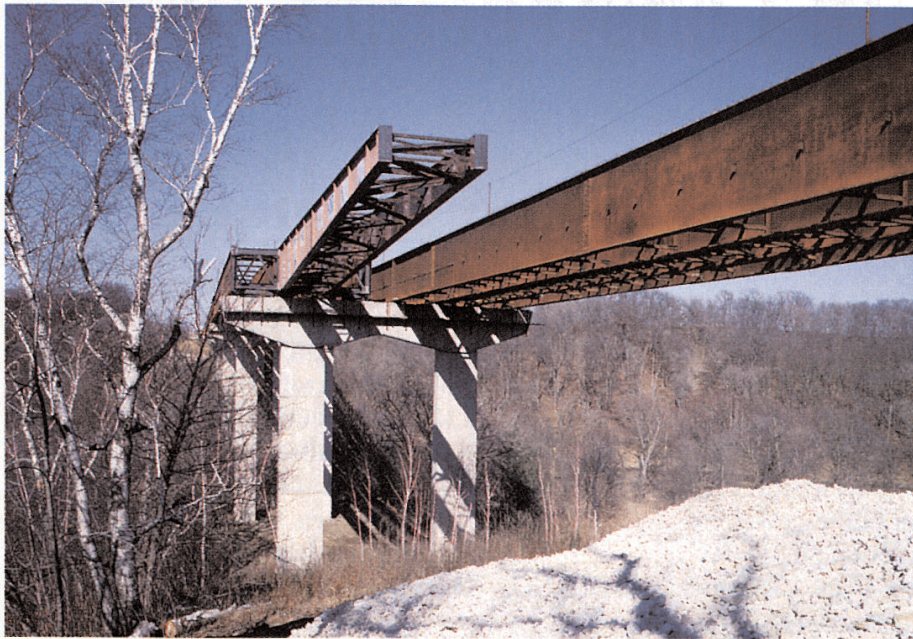
SOARING Launching technique helps carry span over valley and obstacles.

Ashton Engineering, Davenport, Iowa, designed the launching system. The preassembled girders were launched 300 ft from one pier to the next. Piers are up to 160 ft high and supported by 8-ft-dia drilled shafts up to 100 ft deep with cap beams up to 86 ft wide. “The trick was always to have enough weight behind the support so the bridge won’t tip over as you push it,” says LaViolette. “You’re applying a force of 800 kips on the back end of the bridge, and you’ve got a snake of steel 1,500 ft long and you’re trying to keep it corralled in a straight line.”

A tapered nose section extended beyond the girders for 150 ft, to account for deflection. Launchings were postponed when winds were over 20 mph. “It was a big relief to get past that first launch,” recalls LaViolette. “There were
